# Photos RPM, OSC, CIC, ODEQ visit to Wilcox Oil Co Superfund Site

March 20, 2014

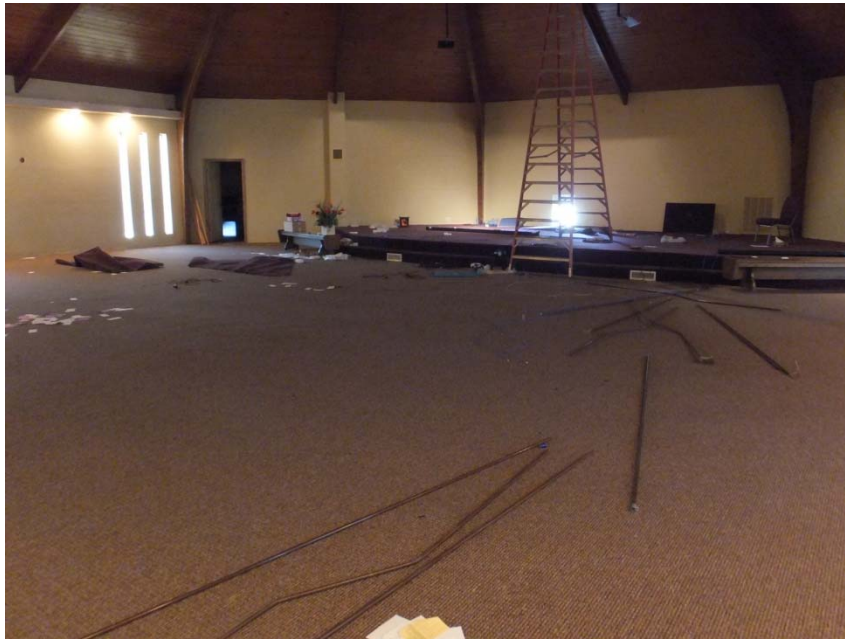
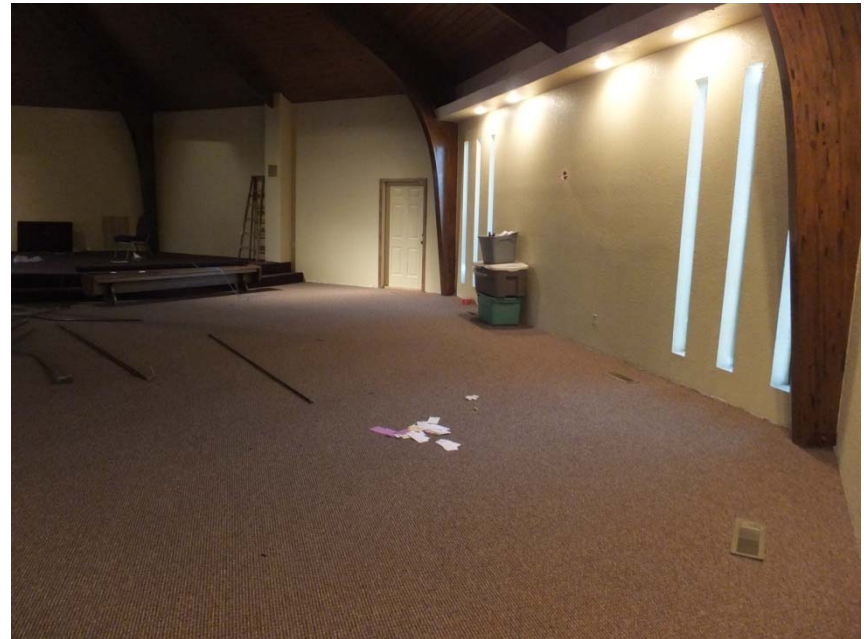
# Church building interior

**Notice wood ceiling, walls, carpet.**

**Building is empty, not in use.**

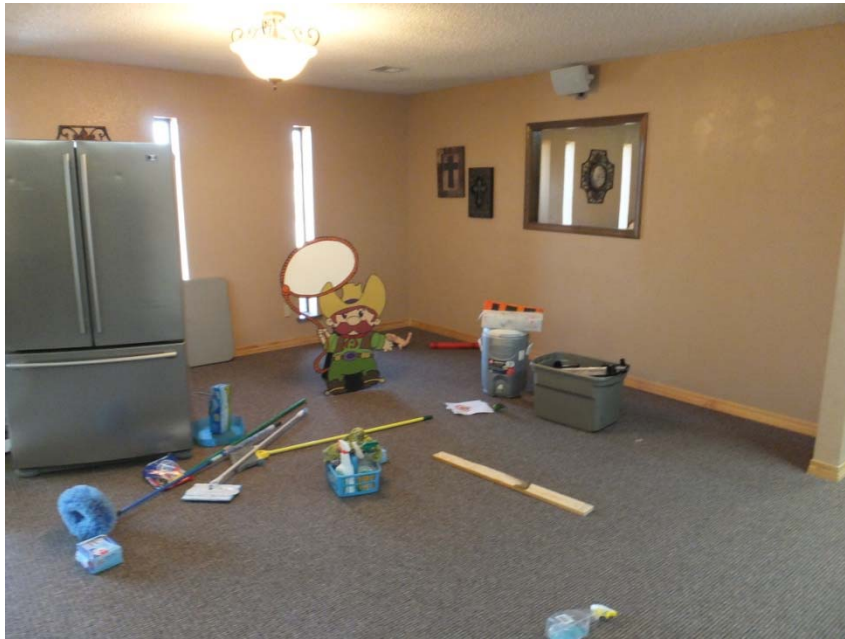
# Church building interior

**Carpet, wall paper, paint**

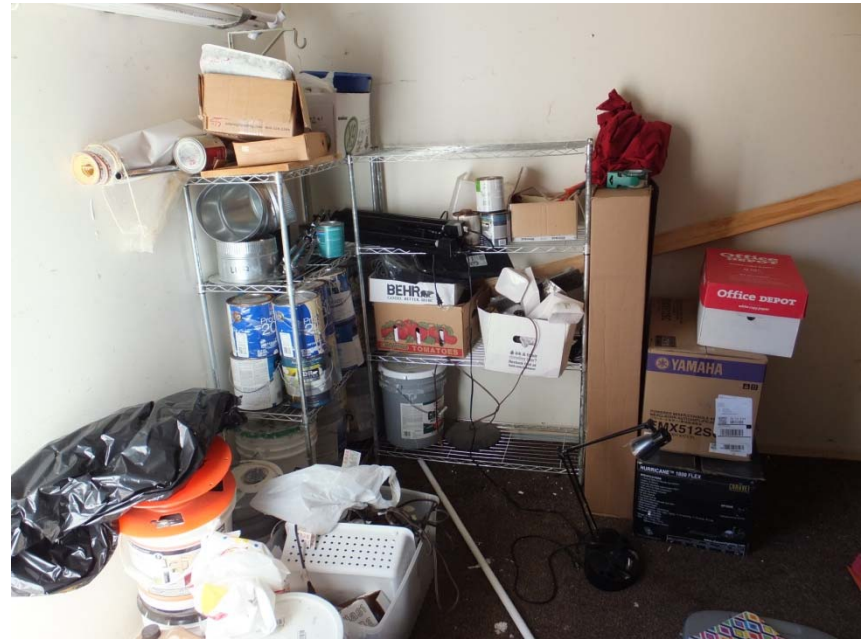
**Storage area**

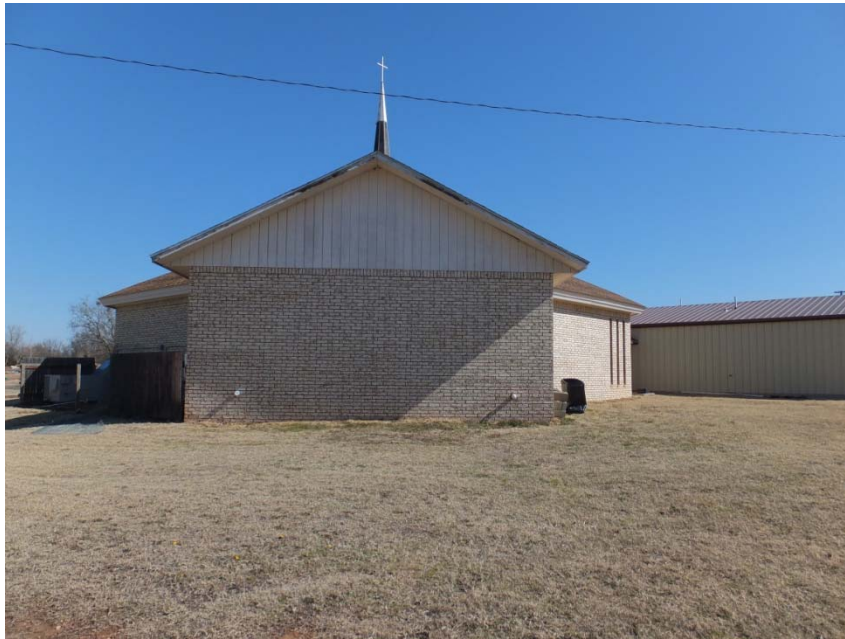
# Church exterior

**Some ground bare spots, see  
next slides**

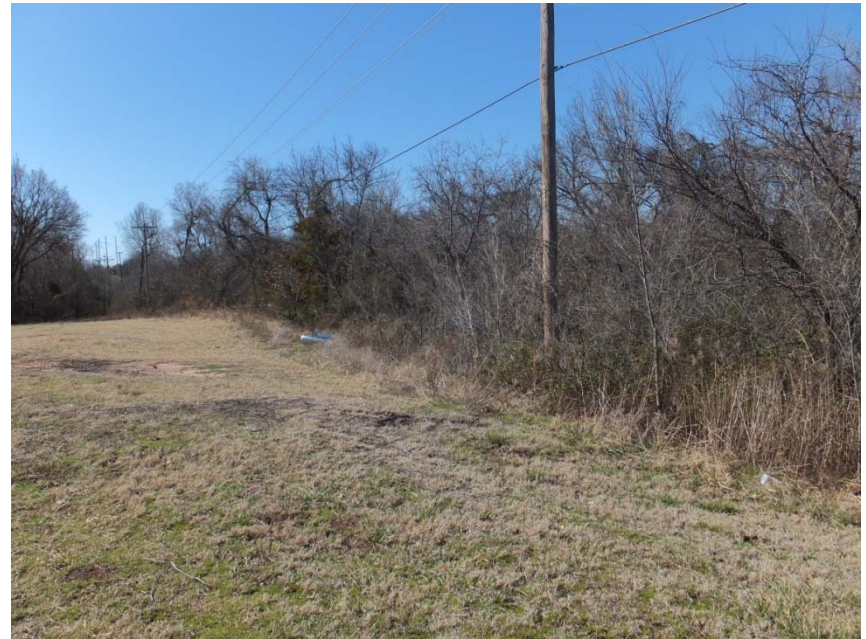
**Slope next to creek**

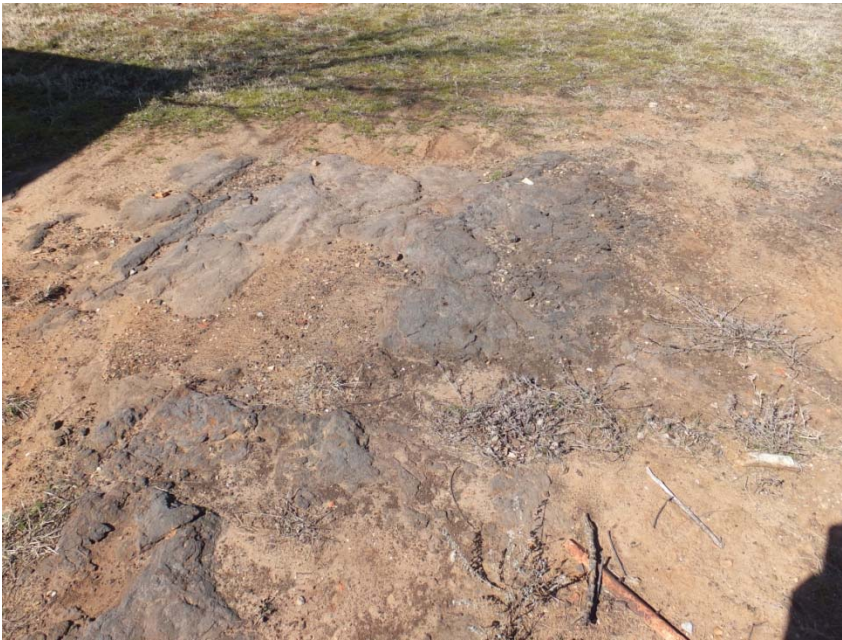
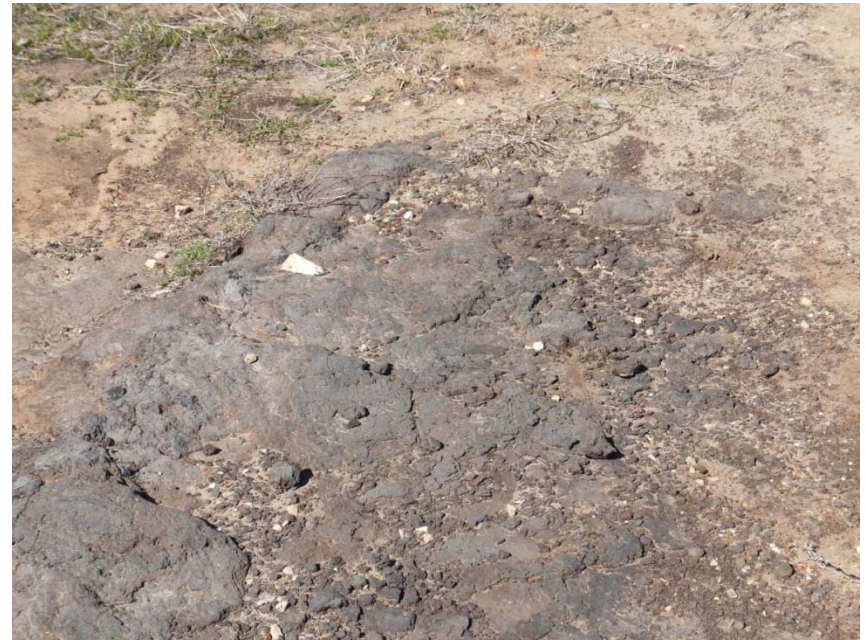
# Closer look of “bare spots”

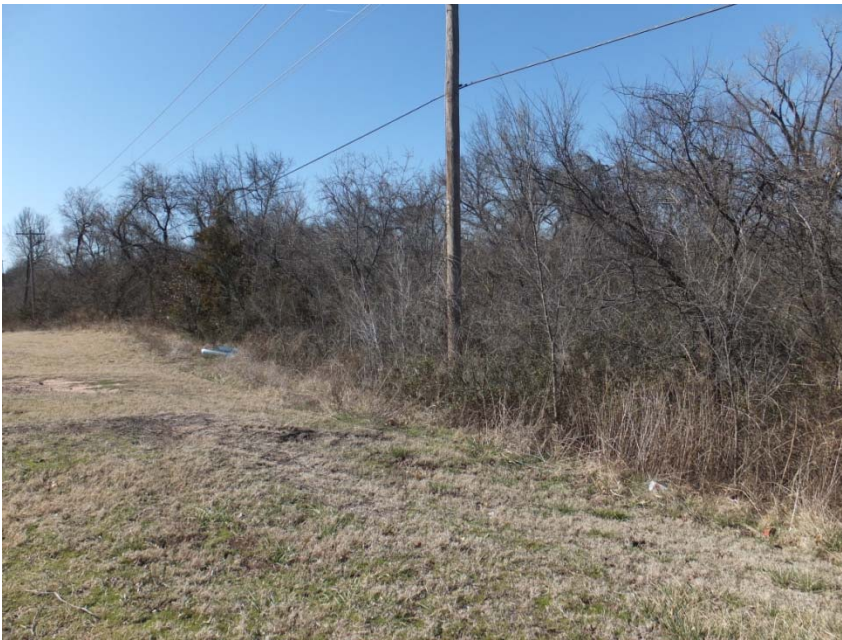
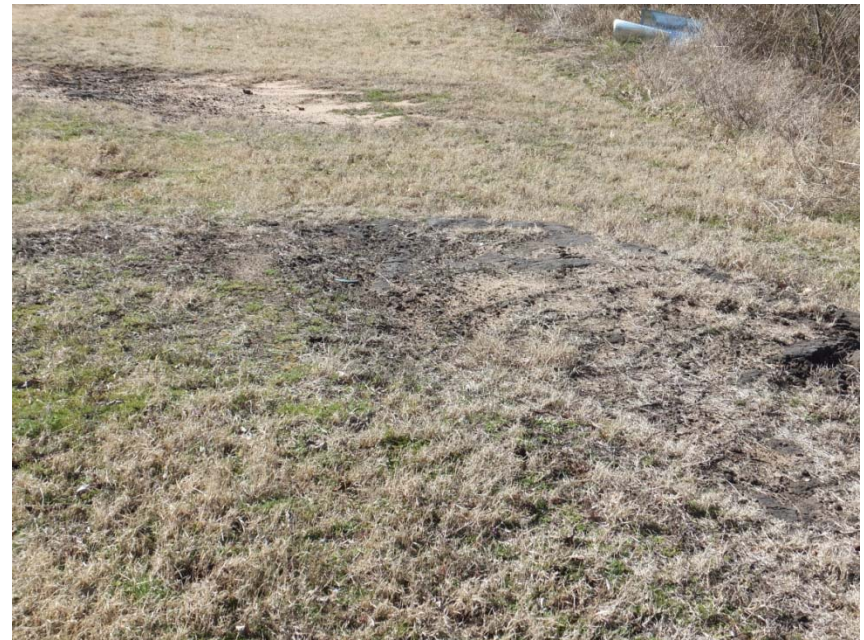
# More “bare spots”, creek behind those shrubs

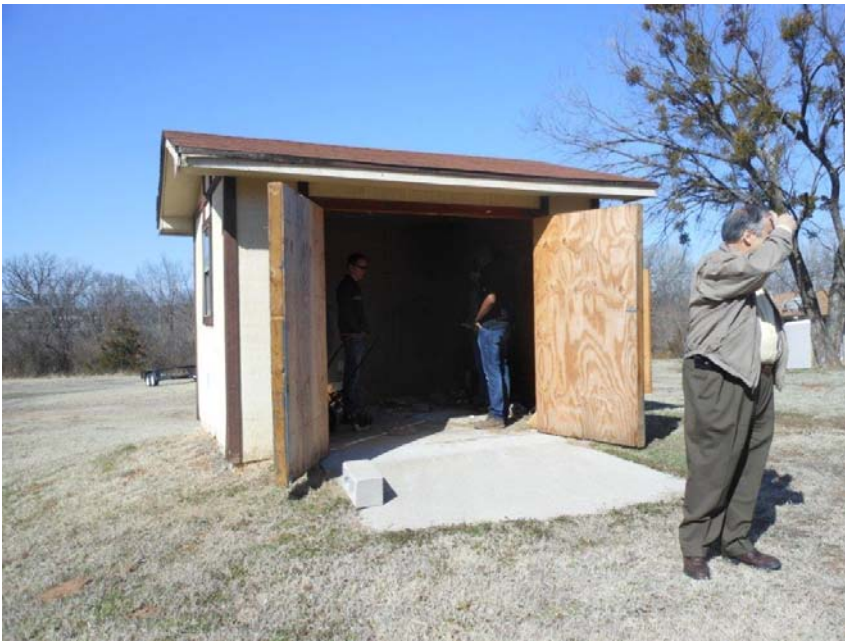
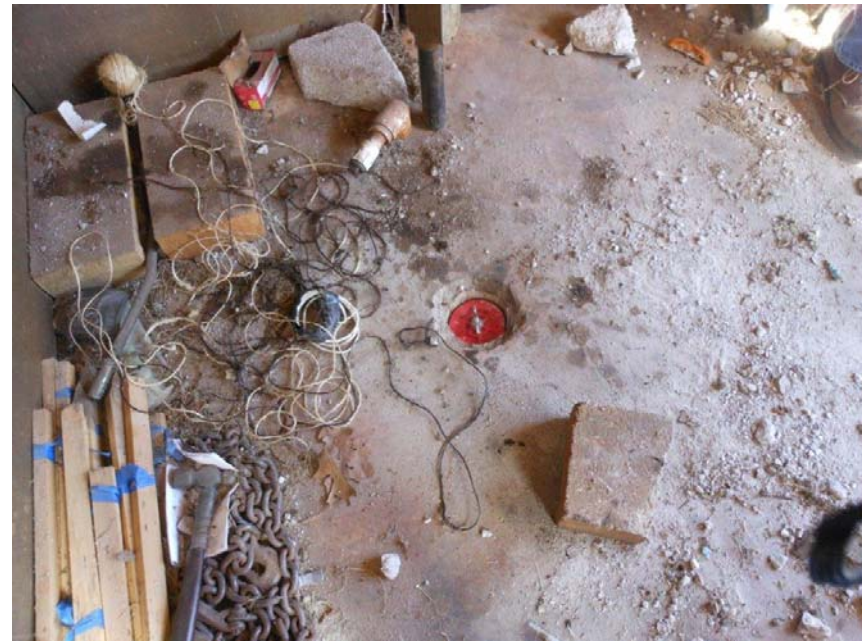
# The Church well

the well plug is the round red thing  
inserted in the well pipe

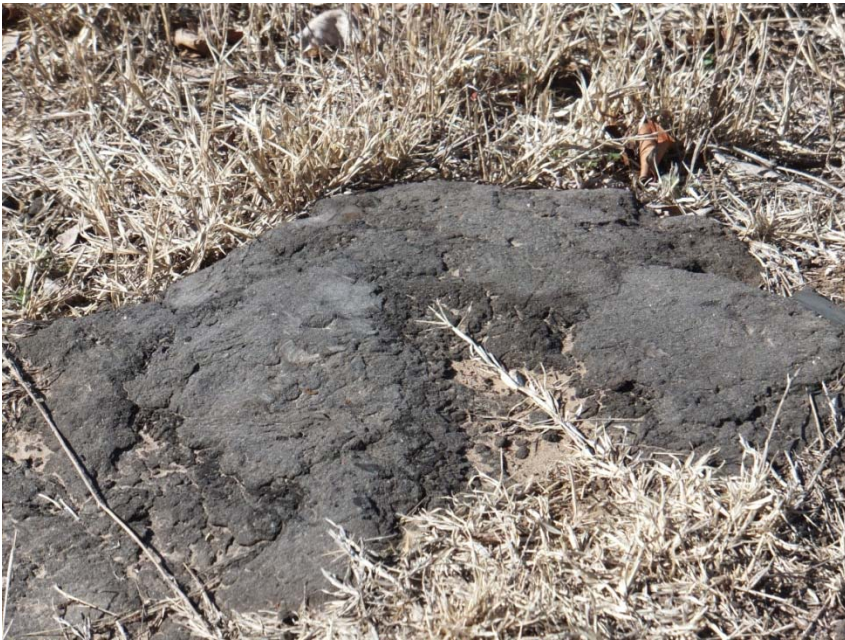
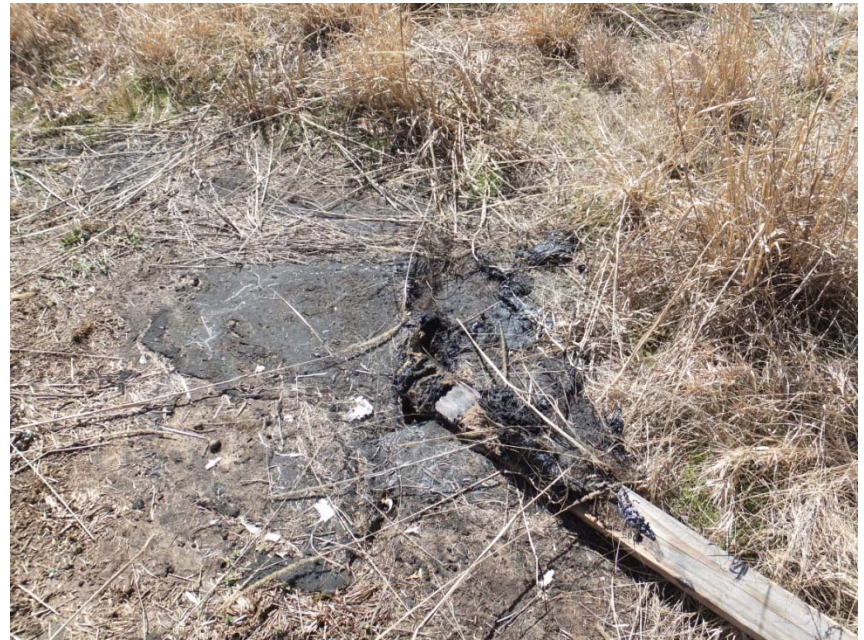
Random spots with black tar, asphaltic  
like, oily material
